DEPARTMENT OF TRANSPORTATION**DIVISION OF ENGINEERING SERVICES**

Contract #: 04-0120F4Cty: SF/ALA Rte: 80 PM: 13.2/13.9File #: 1.28**WELDING INSPECTION REPORT****Resident Engineer:** Casey, William**Address:** 333 Burma Road**City:** Oakland, CA 94607**Report No:** WIR-027951**Date Inspected:** 11-Jul-2012**Project Name:** SAS Superstructure**OSM Arrival Time:** 700**Prime Contractor:** American Bridge/Fluor Enterprises, a JV**OSM Departure Time:** 1930**Contractor:** American Bridge/Fluor Enterprises, a JV**Location:** jobsite

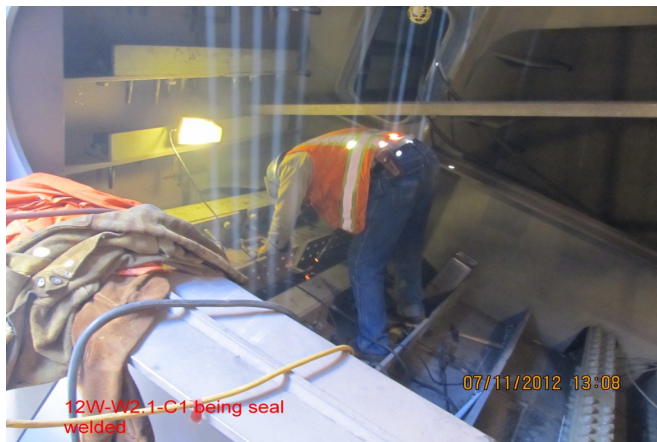
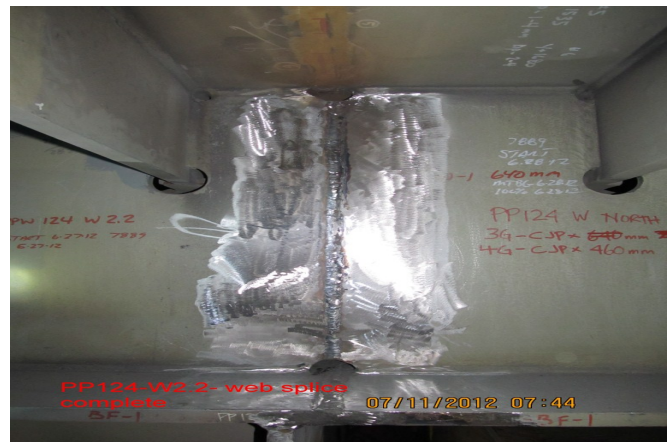
This QAI performed Magnetic Particle Testing on Deck Splice 13W-123.6 at a specified frequency of 10% of the total length of weld. No indications were noted. Please see Magnetic Particle Testing report dated 7/11/12 for further details.
